**SUBJECT: FINAL PHASE III REMOVAL ASSESSMENT TRIP REPORT –
CANADIAN RADIUM AND URANIUM CORP. SITE, MOUNT KISCO,
WESTCHESTER COUNTY, NEW YORK**

FINAL PHASE III REMOVAL ASSESSMENT TRIP REPORT

**CANADIAN RADIUM AND URANIUM CORP. SITE
MOUNT KISCO, WESTCHESTER COUNTY, NEW YORK**

SITE NAME: Canadian Radium and Uranium Corp. Site
DC No.: RST3-03-D-0206
TDD No.: 0007-0023
CERCLIS ID: NYD987001468
EPA ID: A23P
EVENT DATES: December 12 through 14, 2016

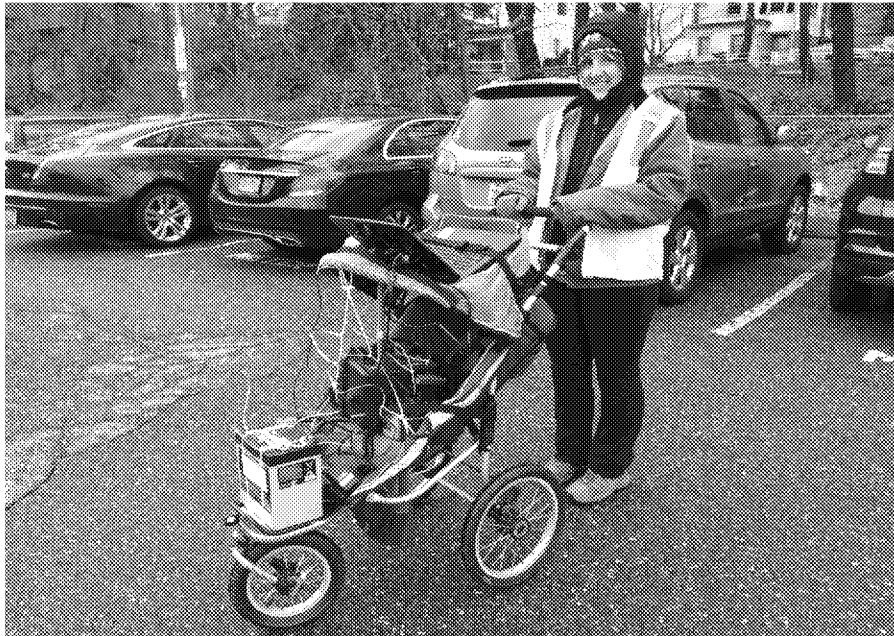
Photograph 1: Weston Solutions, Inc., Removal Support Team 3 (RST 3) personnel conducting gamma survey at the parking lot immediately adjacent to the Site on the eastern side of the railroad tracks and fronting on North Moger Avenue (Property C007) using a Ludlum-2241 Scaler Ratemeter with sodium iodide (NaI) 3x3 scintillator attachment. A baby buggy stroller was utilized to provide mobility for the survey instrumentation setup.

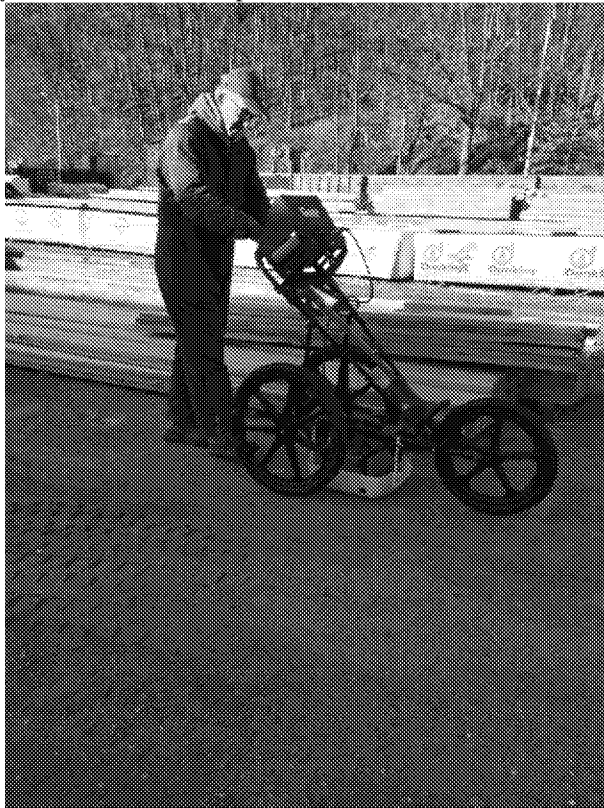
Photograph 2: Prior to conducting any drilling activities on-site, RST 3 drilling subcontractor, Environmental Field Services, Inc. (EFS), cleared each proposed temporary well point location for subsurface utilities using a ground penetrating radar (GPR).

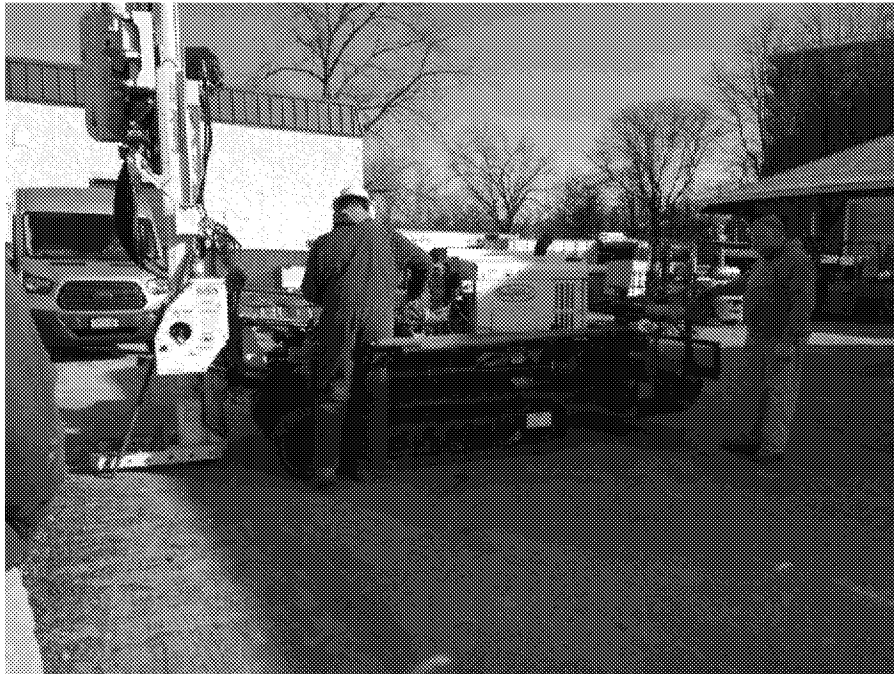
Photograph 3: EFS installed the temporary well points using a Geoprobe™ (Model 7822DT) to advance borings to the desired depths.

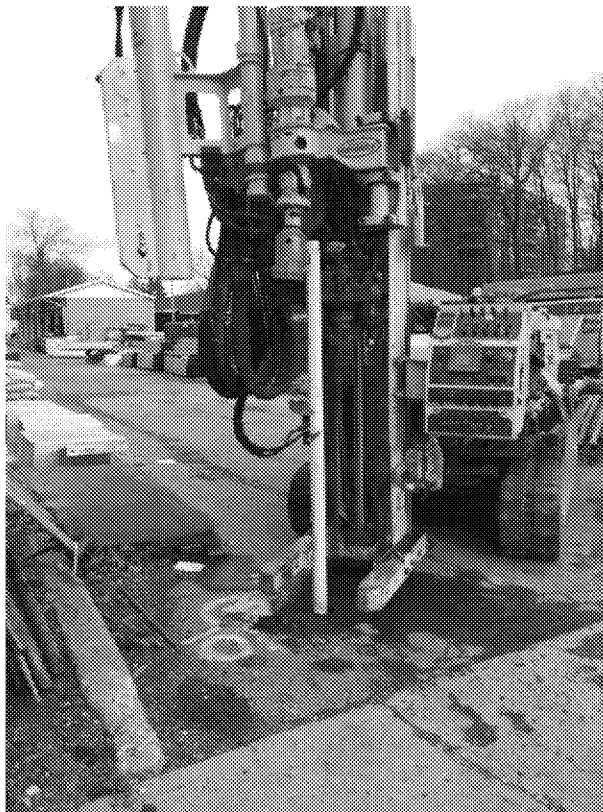
Photograph 4: The construction of each temporary well point consisted of a 10 foot 2-inch Schedule 40 polyvinyl chloride (PVC) screen (0.01 slot) plugged at the base with a PVC cap, and a 5 foot 2-inch Schedule 40 PVC casing with at least a 1 foot riser.

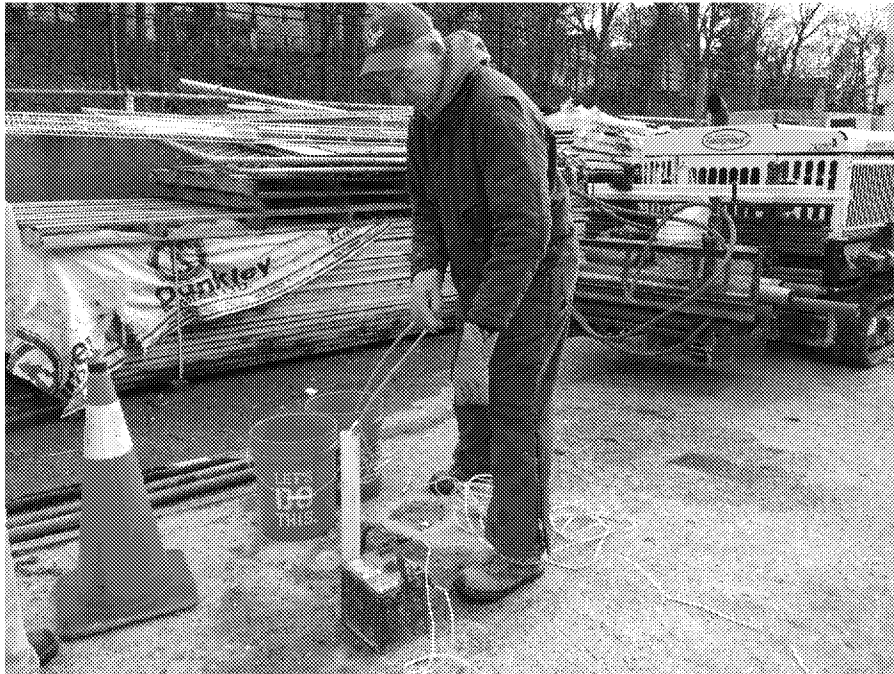
Photograph 5: After the temporary well points were installed, they were purged and surged with a Whale pump to facilitate influx of fresh groundwater from the aquifer, and then allowed to stabilize overnight.

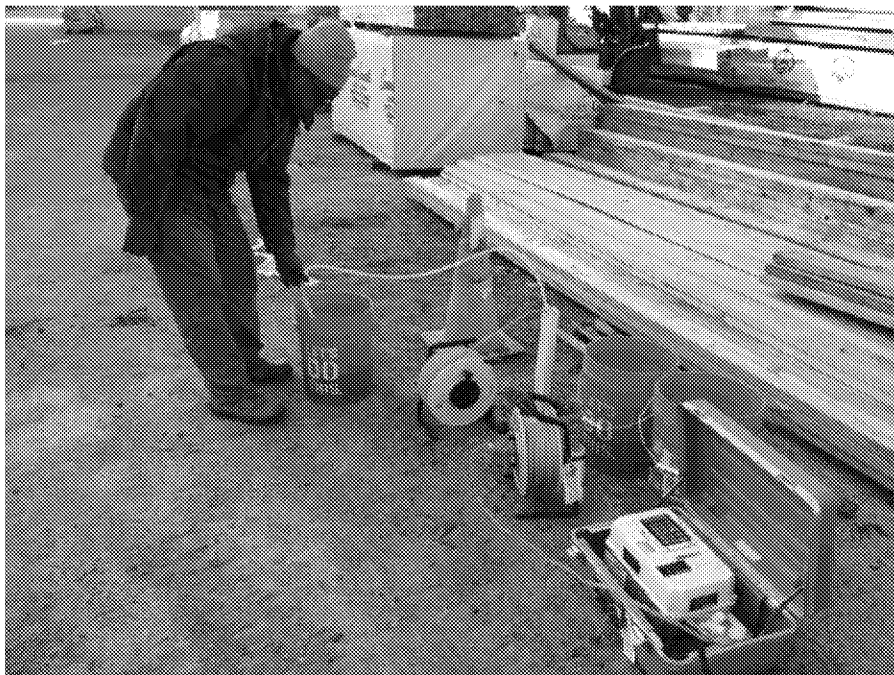
Photograph 6: A Solinst water level meter was utilized by RST 3 to record the water levels and total depths of the temporary well points prior to purging for sampling purposes. Utilizing a non-dedicated submersible Grundfos pump fitted with Teflon™ tubing, RST 3 purged at least three well volumes from each temporary well prior to sample collection.

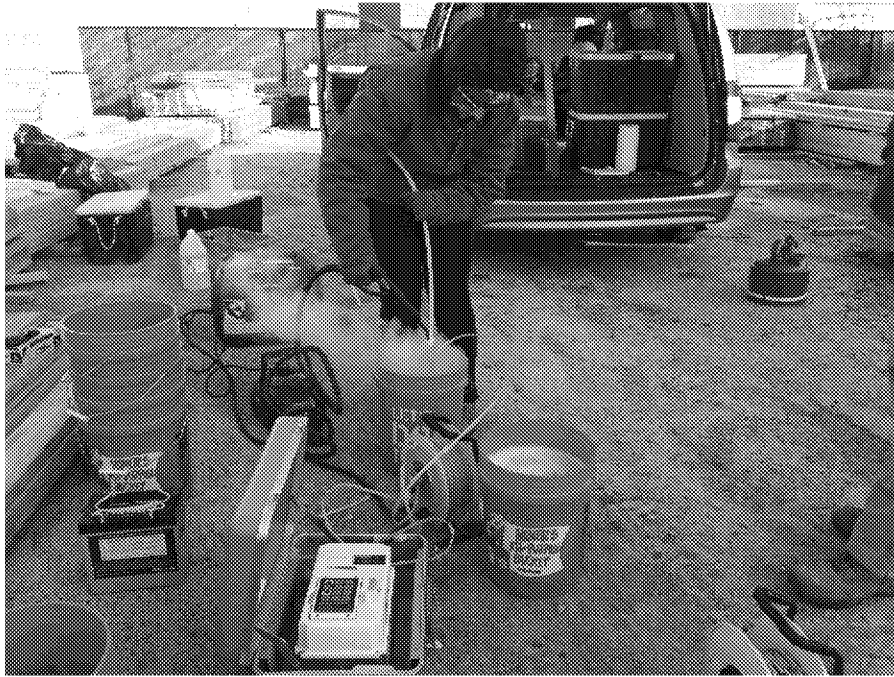
Photograph 7: Decontamination of the non-dedicated submersible pump was performed before and after sampling each temporary well point, and it involved scrubbing the pump exterior with an industrial soap (Alconox) and water, running the pump in a bucket of Alconox and water for 5 minutes, rinsing the pump exterior with tap water, running the pump in a bucket of tap water, steam cleaning the pump with deionized (DI) water, and air dry.

Decontamination of the non-dedicated submersible pump was performed before and after sampling each temporary well point, and it involved scrubbing the pump exterior with an industrial soap

(Alconox) and water, running the pump in a bucket of Alconox and water for 5 minutes, rinsing the pump exterior with tap water, running the pump in a bucket of tap water, steam cleaning the pump with deionized (DI) water, and air dry. A rinsate blank was collected to verify proper decontamination of non-dedicated sampling equipment (*i.e.*, submersible pump). Per the EPA OSC's directive, once the temporary well points were sampled, the investigation-derived waste (IDW), including well development purge water, sampling purge water, and decontamination fluids, were pumped back into each temporary well point. The boreholes were then backfilled in reverse order with the extracted soil in the cores, tamped down, and sealed with bentonite.

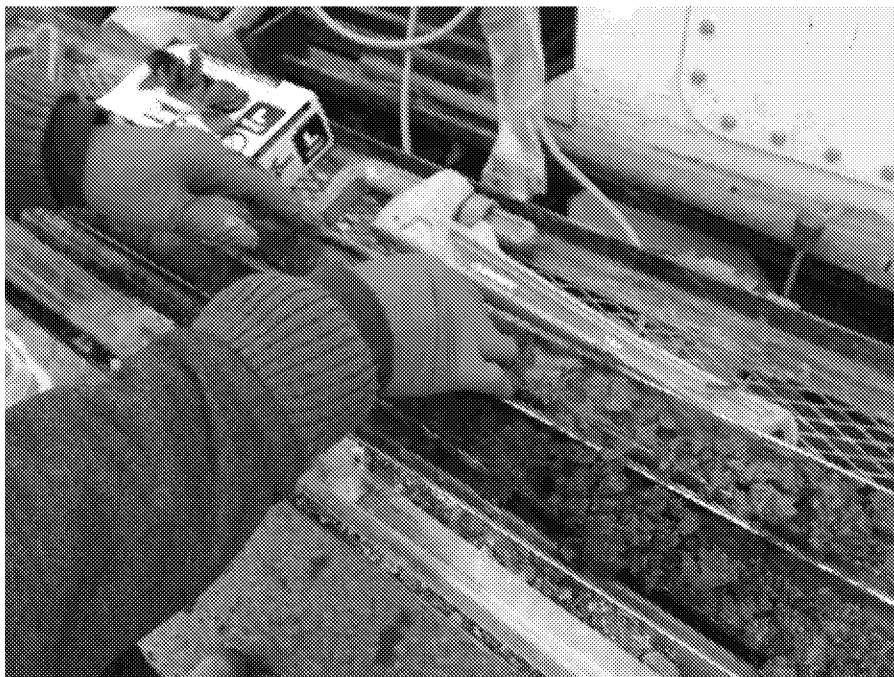
Photograph 8: RST 3 documented the physical characteristics and description of the soils extracted in each core from each boring location

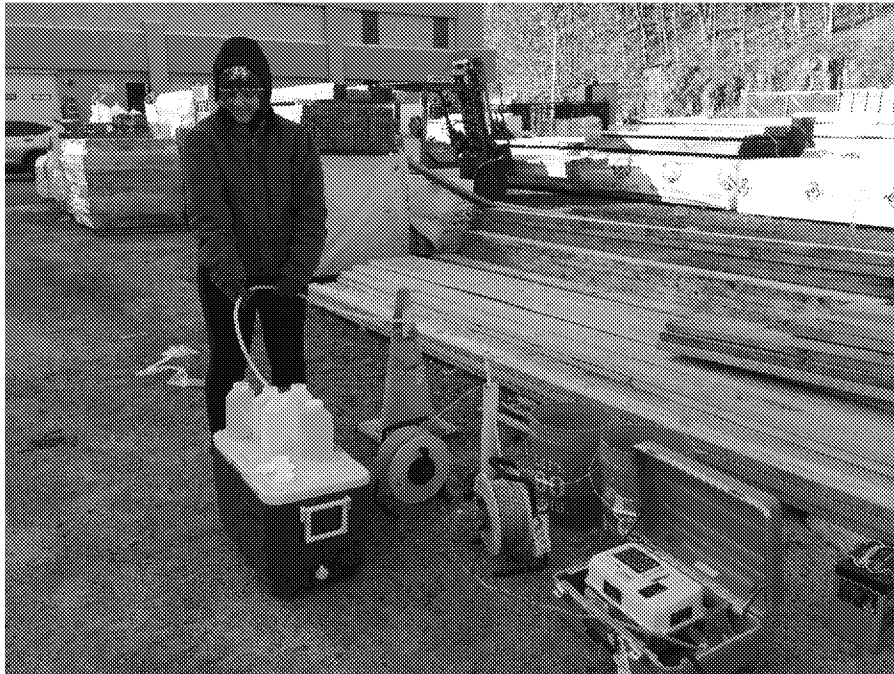
Photograph 9: RST 3 collected groundwater samples directly from the dedicated Teflon™ tubing utilized to purge each temporary well.

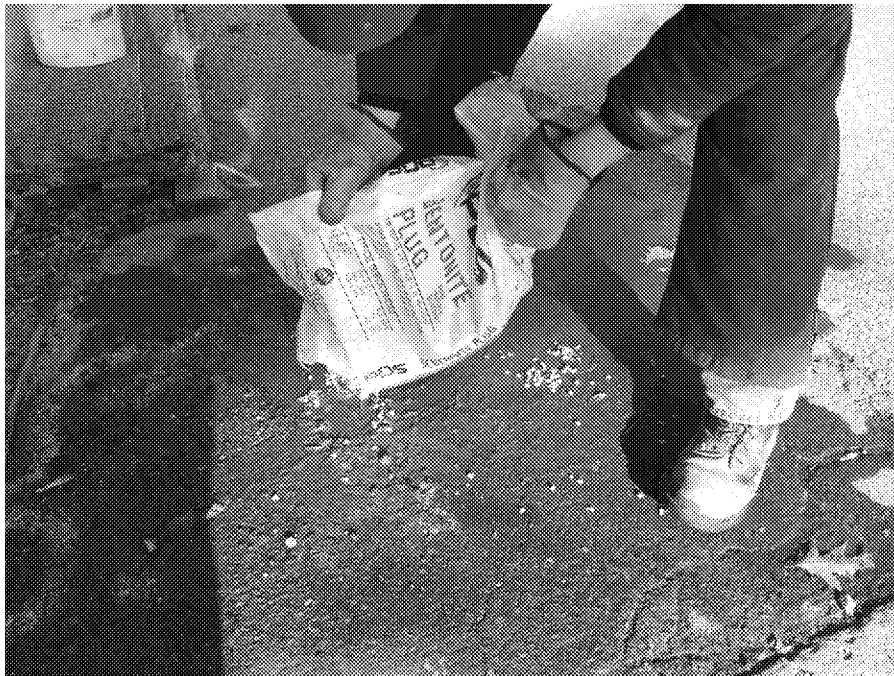
Photograph 10: Per the EPA OSC's directive, once the temporary well points were sampled, the investigation-derived waste (IDW), including well development purge water, sampling purge water, and decontamination fluid, were pumped back into each temporary well point. The boreholes were then backfilled in reverse order with the extracted soil in the cores, tamped down, and sealed with bentonite.
